I KNOW A GUY HOME INSPECTIONS LLC

1234 Main Street
Colorado Springs, CO 80918

Buyer Name
05/28/2023 9:00AM

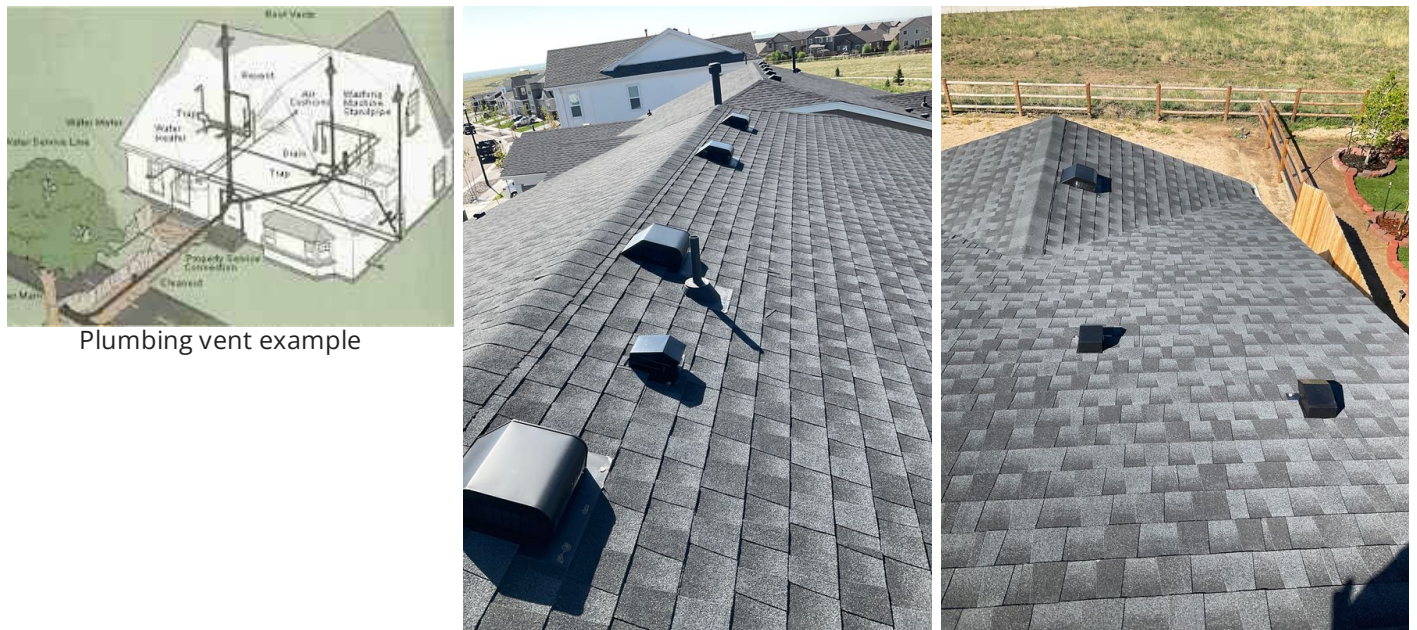
Plumbing Vent Pipes: Plumbing Vent Pipes Inspected

I looked at DWV (drain, waste and vent) pipes that pass through the roof covering. There should be watertight flashing (often black rubber material) installed around the vent pipes. These plumbing vent pipes should extend far enough above the roof surface.

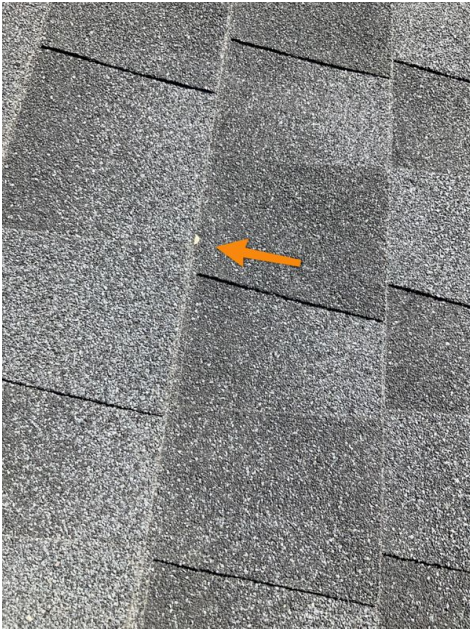
South East front

I observed indications of exposed fasteners at the roof-covering materials. Fasteners should not be exposed. Potential water entry points. Roof could leak. Further evaluation and correction is recommended.

Recommendation

Contact a qualified roofing professional.

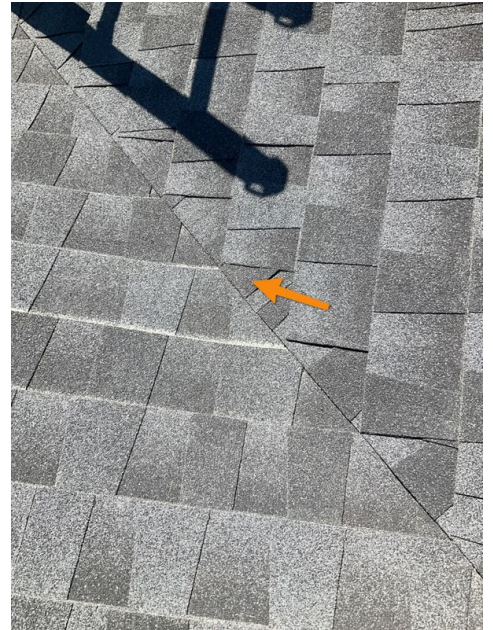
North east valley

2.1.2 Roof Covering

FASTENING DEFECT AT ROOF COVERING

Major Defect

I observed improper fastening at the roof-covering materials. Prone to leaking. Correction and further evaluation by a qualified professional recommended.

Recommendation

Contact a qualified roofing professional.

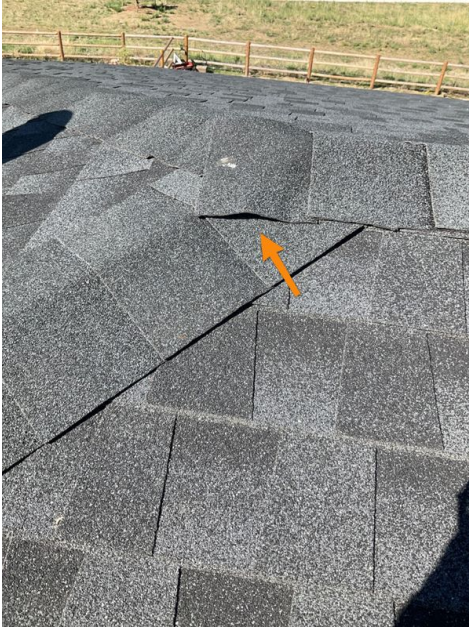
2.1.3 Roof Covering

INSTALLATION DEFECT AT ROOF COVERING

Major Defect

I observed indications of improperly installed roof-covering materials. This is not according to best practices or common standards. Defect. Prone to water intrusion and roof leaks. Further evaluation and correction by a roofer is recommended.

Recommendation

Contact a qualified roofing professional.

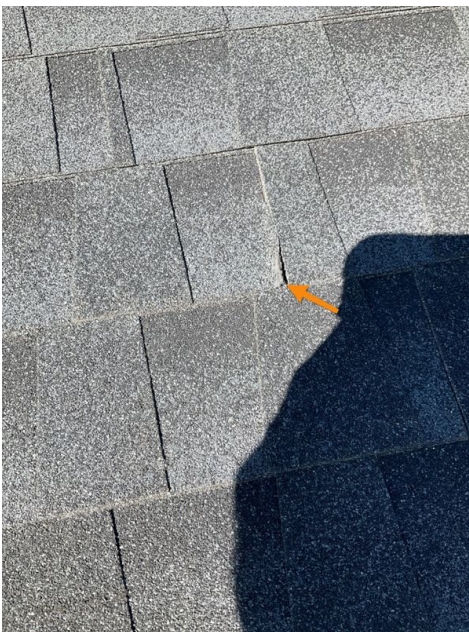
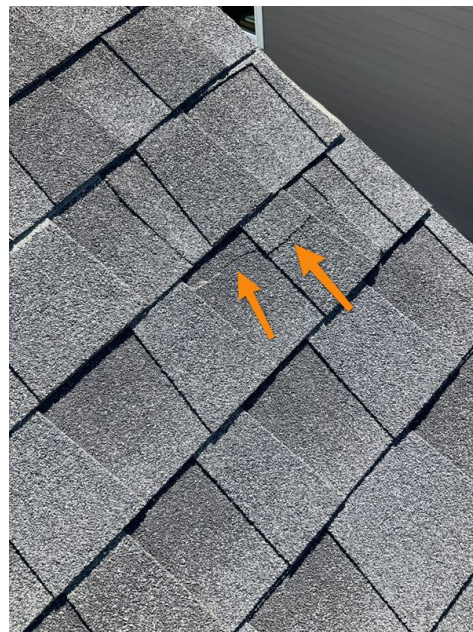
2.1.4 Roof Covering

CRACKED AND DAMAGED ROOF COVERING

Major Defect

I observed areas of cracked/splitting and damaged roof-covering materials. This is a major defect. Prone to water leaking into the house. I recommend further evaluation by a qualified roofer.

Recommendation

Contact a qualified roofing professional.

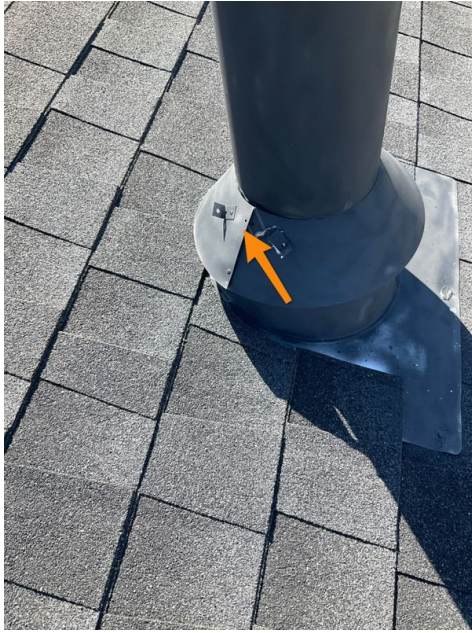
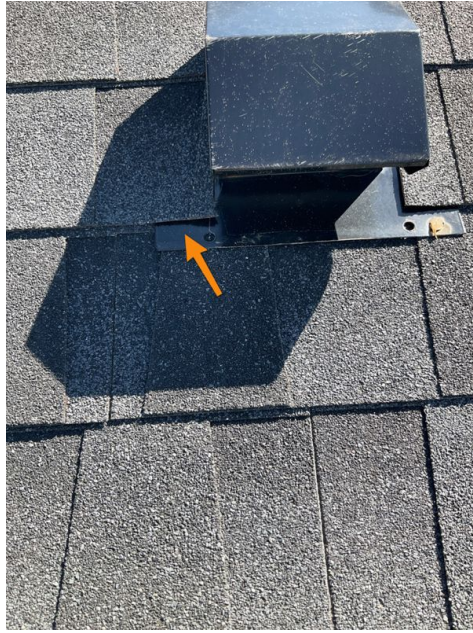
2.3.1 Plumbing Vent Pipes

VENT PIPE FLASHING WAS IMPROPERLY FASTENED

Major Defect

The fastening around the vent pipe was not properly installed. This is prone to water penetration. Correction and further evaluation is recommended by a qualified professional.

Missing Fastner

Recommendation

Contact a qualified roofing professional.

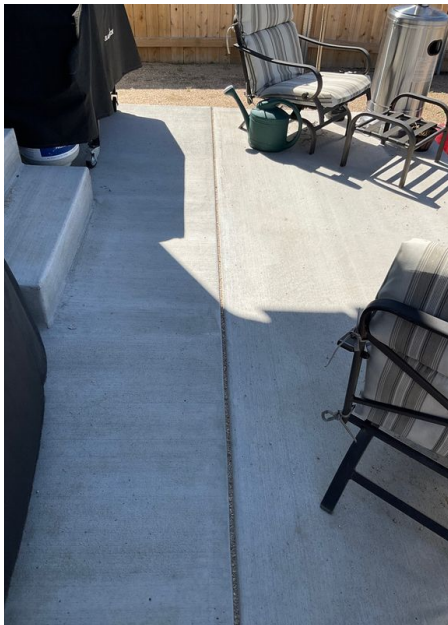
Rear patio

I inspected the porches, patios, decks, balconies and carports at the house that were within the scope of the home inspection.

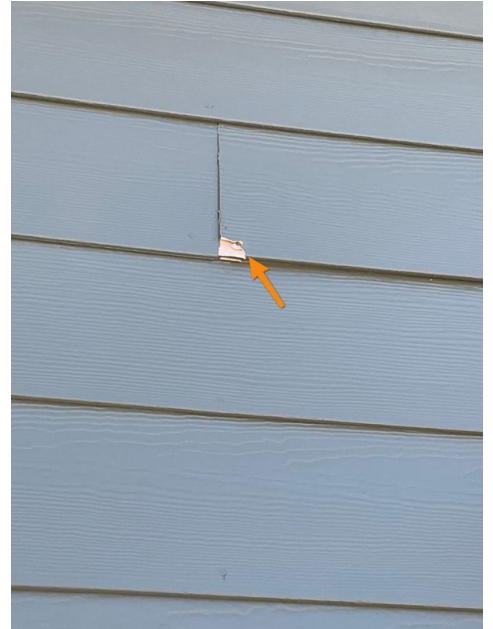
West

DAMAGED WALL-COVERING MATERIAL

Major Defect

I observed indications of a damage of the exterior wall-covering material. Recommend further evaluation, and repair from a qualified professional.

Recommendation

Contact a qualified professional.

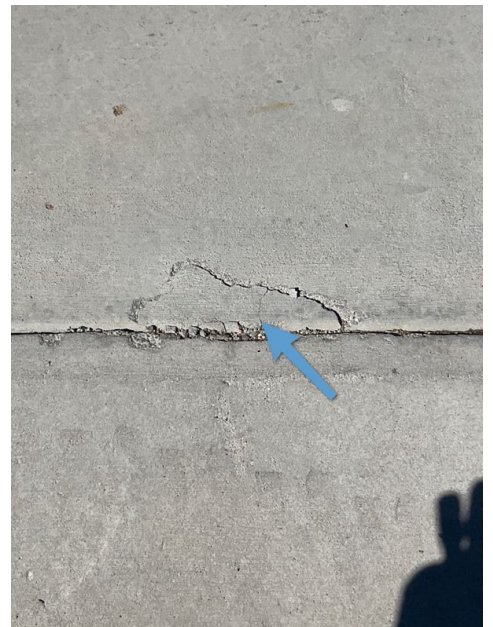
4.6.1 Walkways & Driveways

MINOR CRACKING AT DRIVEWAY.

Minor Defect

I observed minor cracking at drive. Recommend filling minor cracks with sealant, to prevent the intrusion of moisture causing further damage.

Monitoring is recommended.

Recommendation

Contact a qualified handyman.

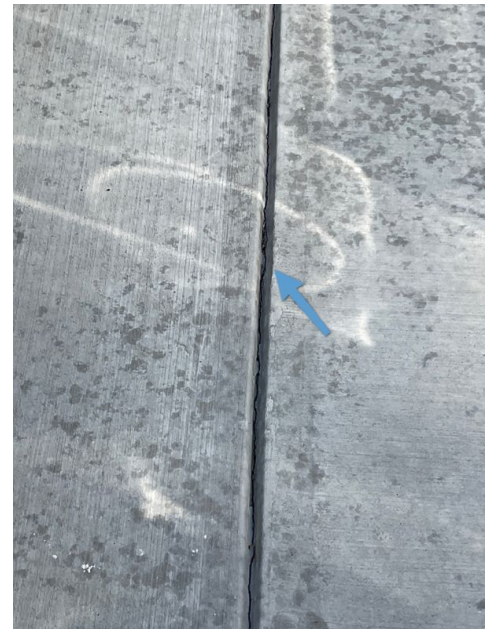
4.6.2 Walkways & Driveways

CAULKING IN EXPASTION JOINTS

Minor Defect

Recommend caulking in driveway expansion points to prevent water intrusion.

Recommendation

Contact a qualified handyman.

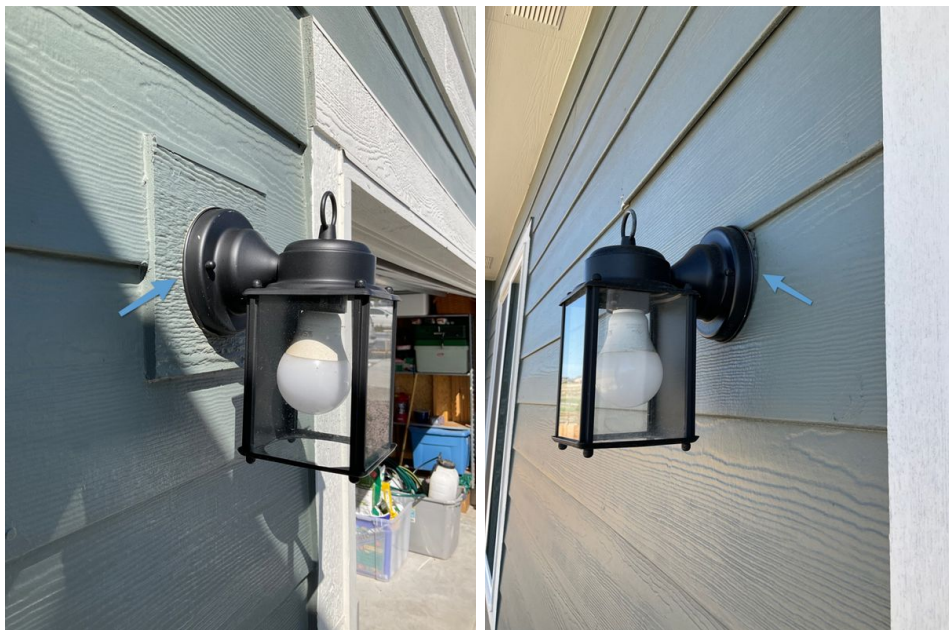
Garage

4.11.1 Exterior Lighting

MISSING EXTERIOR LIGHT CAULKING

Minor Defect

Recommendation

Contact a qualified handyman.

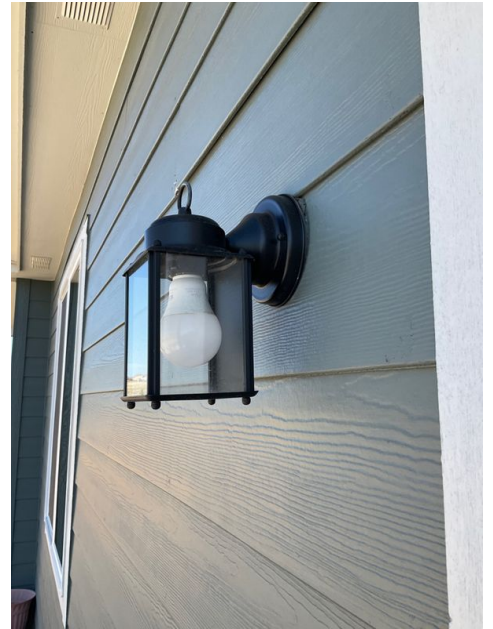
Back door

4.11.2 Exterior Lighting

LOOSE EXTERIOR FIXTURE

Minor Defect

I observed loose exterior fixture. Fixture needs to be secure.

Recommendation

Contact a qualified handyman.

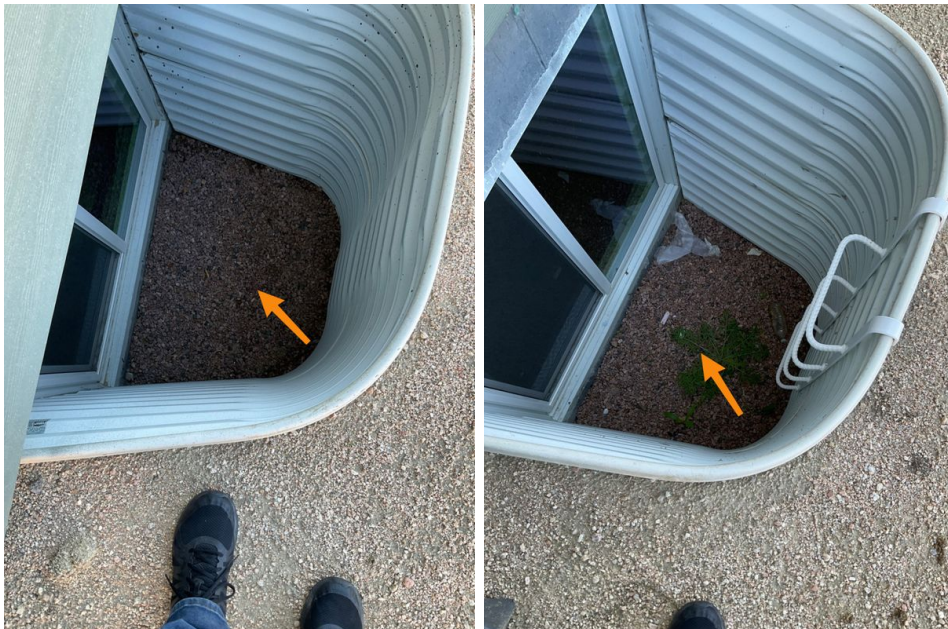
4.12.1 Window Wells

Major Defect

NO DRAINS OBSERVED

I did not observe that window well had drains. Recommend confirming that has drain, in order to prevent possible water intrusion into lower level of house.

Recommendation

Contact a qualified professional.

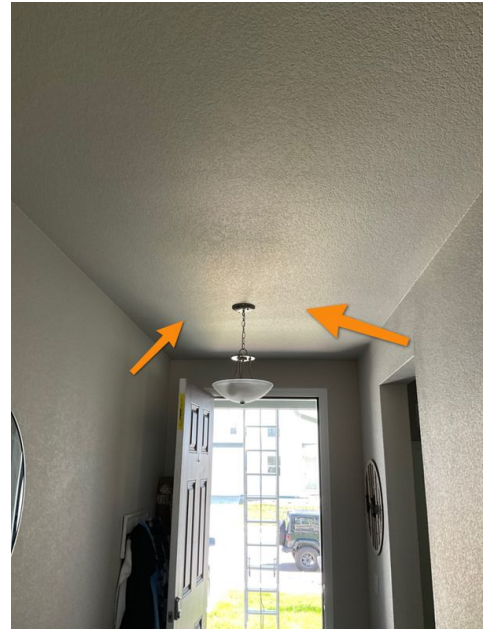
I observed a light fixture that was not centered. Recommend further evaluation and repair by qualified professional.

Recommendation

Contact a qualified professional.

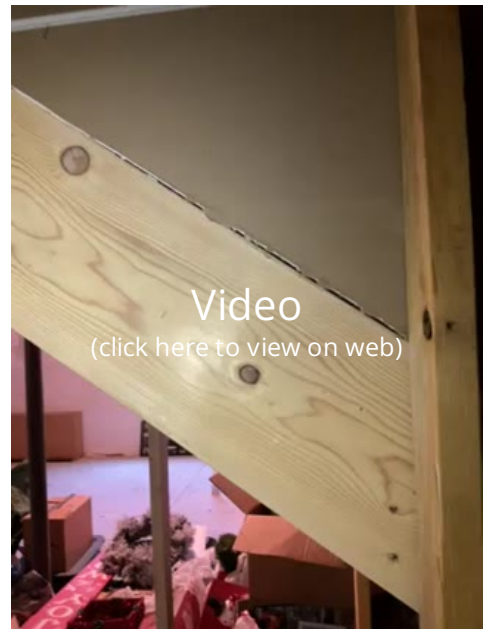
5.3.1 Stairs, Steps, Stoops, Stairways & Ramps

Major Defect

I observed the stair stringers flexing, While in use. Recommend further evaluation and correction by qualified professional.

Recommendation

Contact a qualified professional.

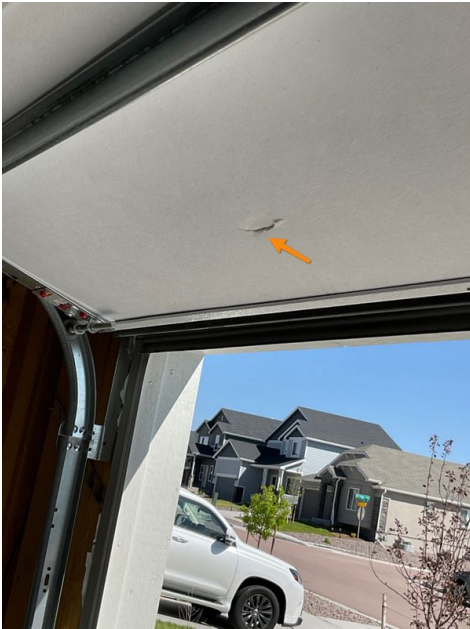
7.2.1 Garage Vehicle Door

DAMAGE TO GARAGE DOOR

Major Defect

I observed indications of damage to the garage door itself. Recommend further evaluation and repair from a qualified professional.

Recommendation

Contact a qualified professional.

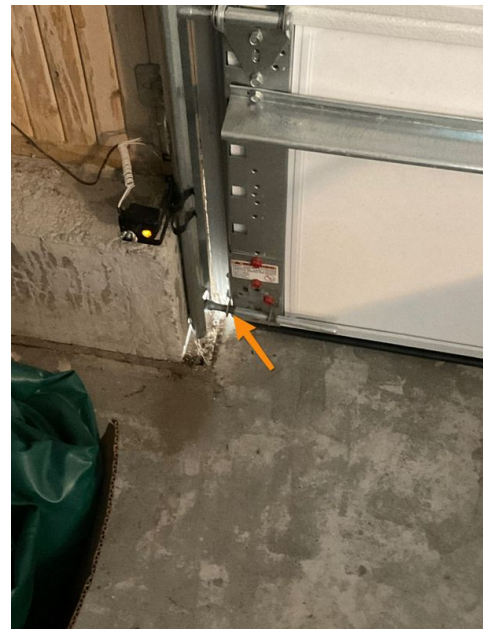
7.2.2 Garage Vehicle Door

GARAGE VEHICLE DOOR SEAL

Major Defect

I observed an opening at the seal on the vehicle garage door.
Recommend further evaluation and repair by qualified professional.

Recommendation

Contact a qualified professional.

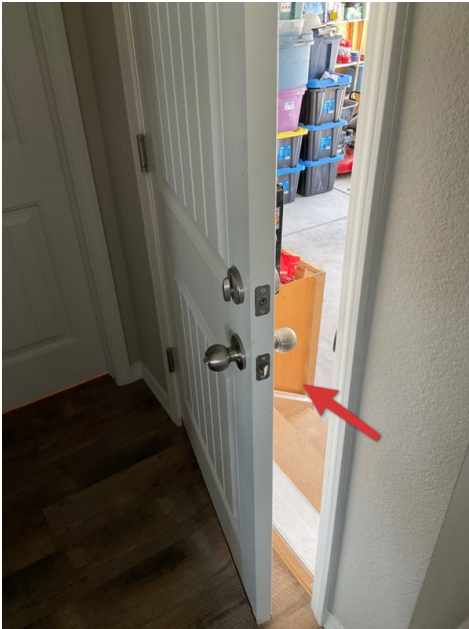
7.6.1 Ceiling, Walls & Firewalls in Garage

DOOR WAS NOT SELF-CLOSING

Material Defect

I observed that the door between the garage and the house is not equipped with a self-closing or an automatic-closing device. This is a fire hazard.

Recommendation

Contact a qualified professional.

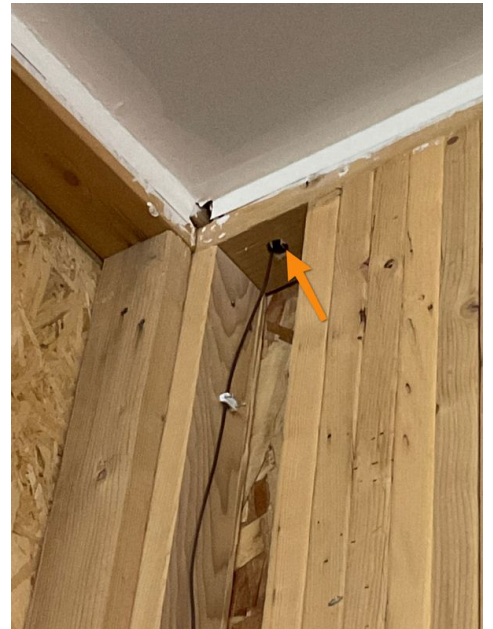
7.6.2 Ceiling, Walls & Firewalls in Garage

OPENING IN CEILING

I observed an opening in the ceiling. No openings in ceiling in garage are allowed. Recommend repair.

Recommendation

Contact a qualified professional.

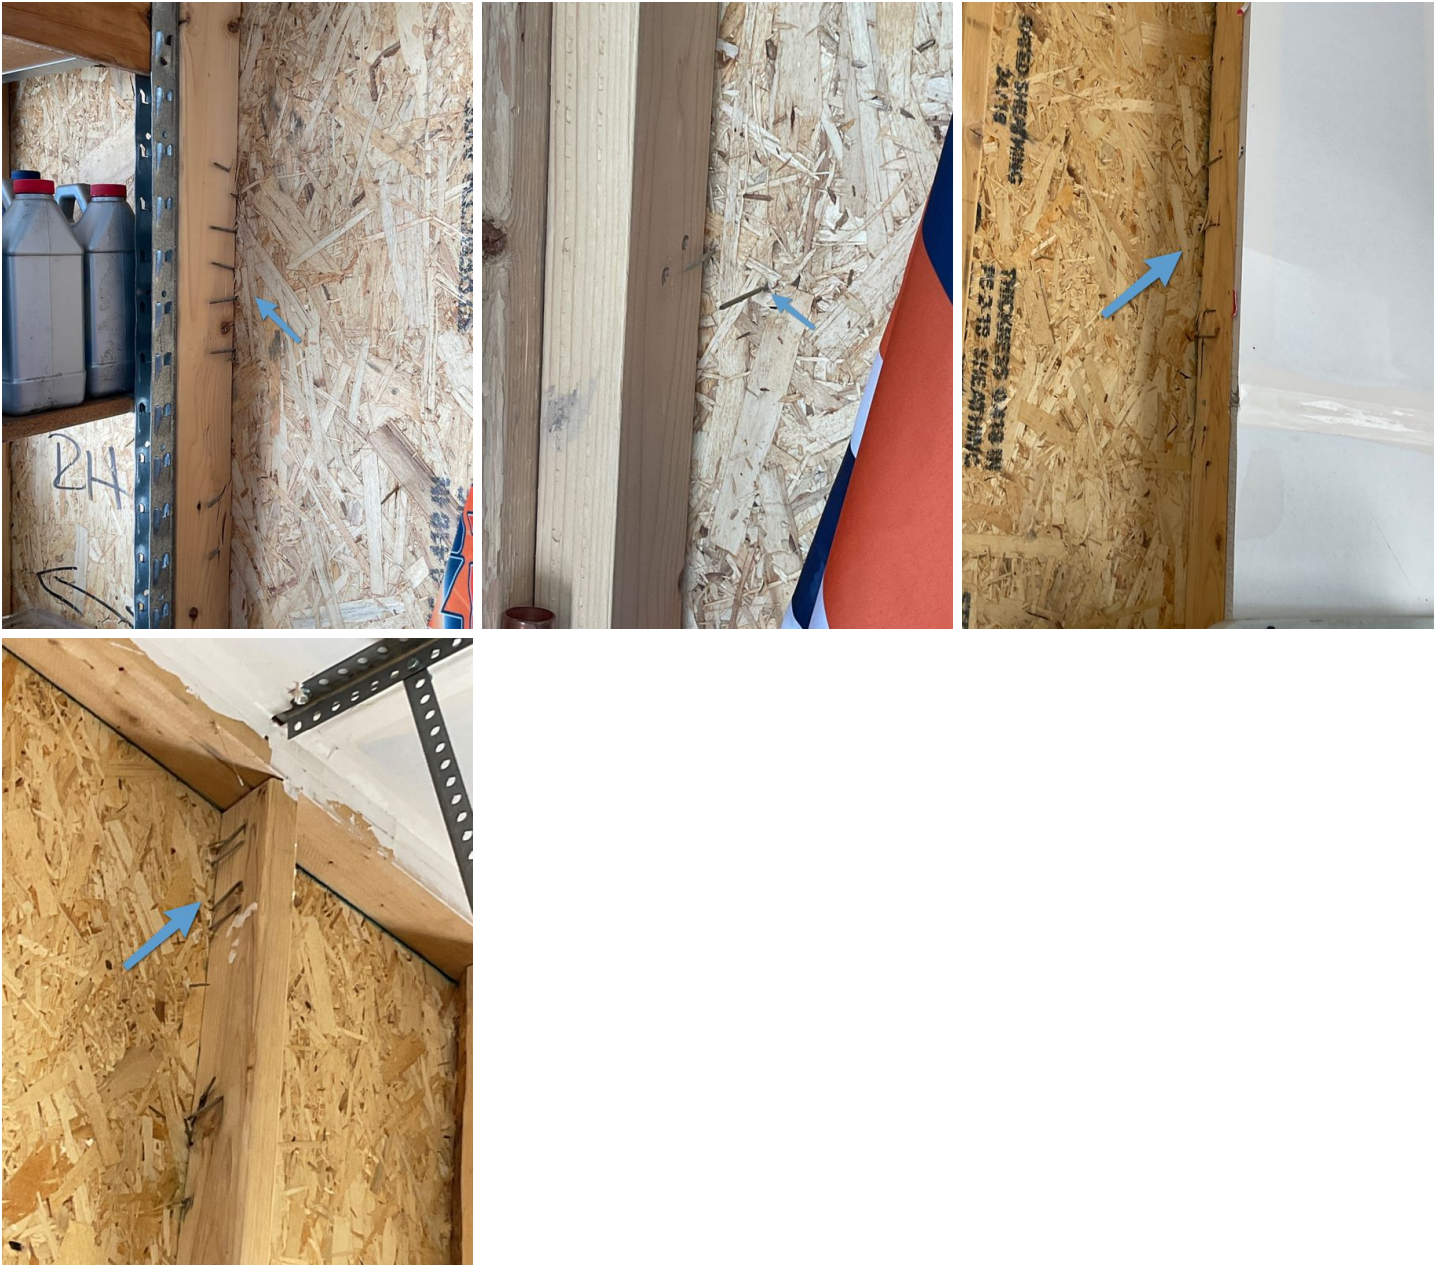
7.6.3 Ceiling, Walls & Firewalls in Garage

NAILS EXPOSED

Nails exposed. This is a safety hazard if to come in contact with.

Recommendation

Contact a qualified professional.

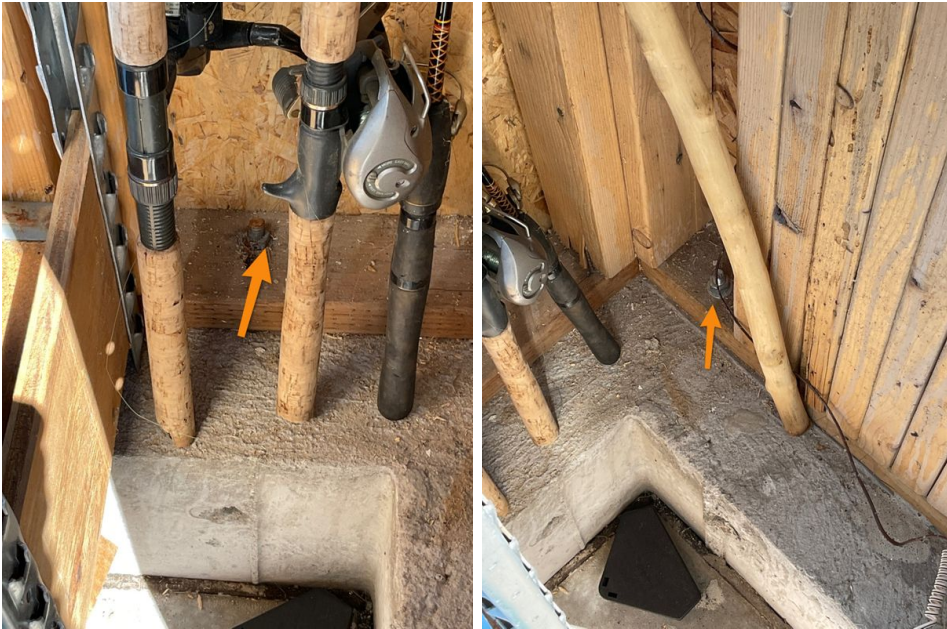
7.6.4 Ceiling, Walls & Firewalls in Garage

LOOSE BOTTOM SILL BOLT

I observed a loose bottom sill bolt. Recommend further evaluation and repair.

Major Defect

Recommendation

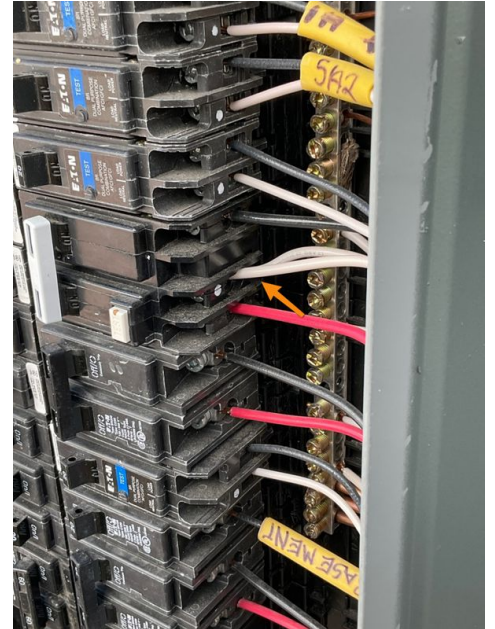
I observed doubled neutral wires connected under the same single lug. Recommend further evaluation and correction by qualified professional.

Recommendation

Contact a qualified electrical contractor.

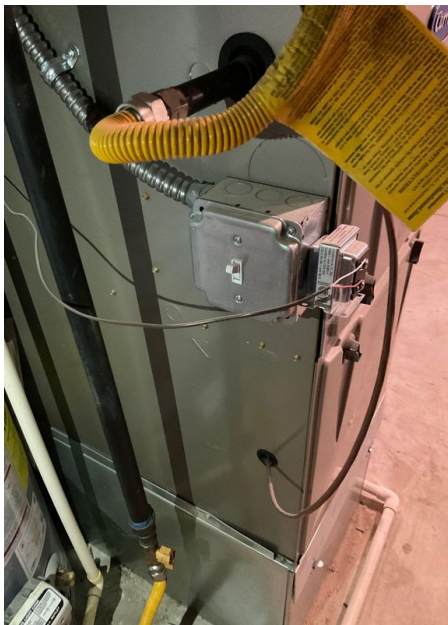
I observed an emergency shut-off switch. I inspected it. It worked when I used it during my inspection.

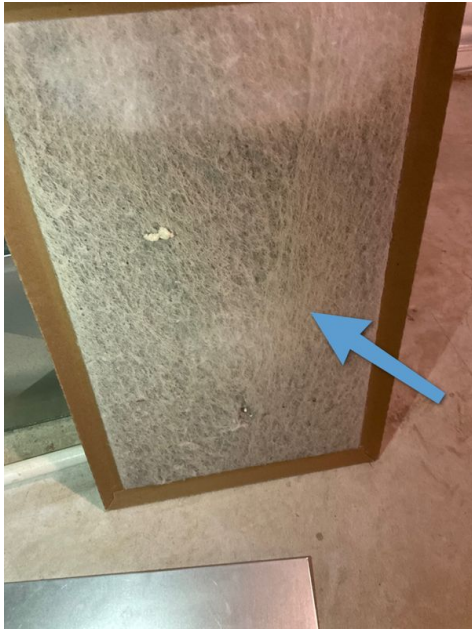
9.1.1 Heating System Information

I observed a dirty air filter at the furnace filter.

Minor Defect

Recommendation

Recommended DIY Project

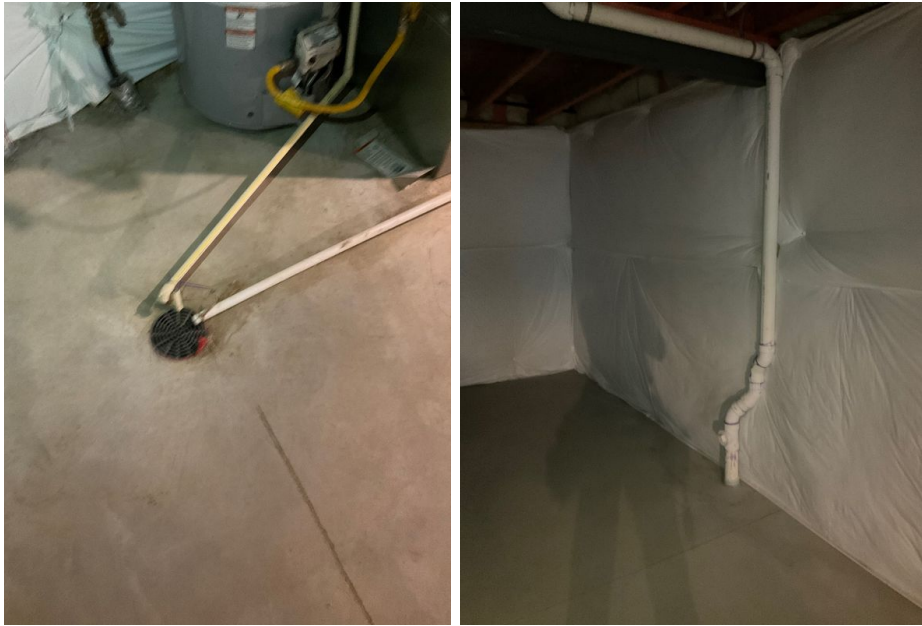
I attempted to inspect the drain, waste, and vent pipes. Not all of the pipes and components were accessible and observed. Inspection restriction. Ask the homeowner about water and sewer leaks or blockages in the past.

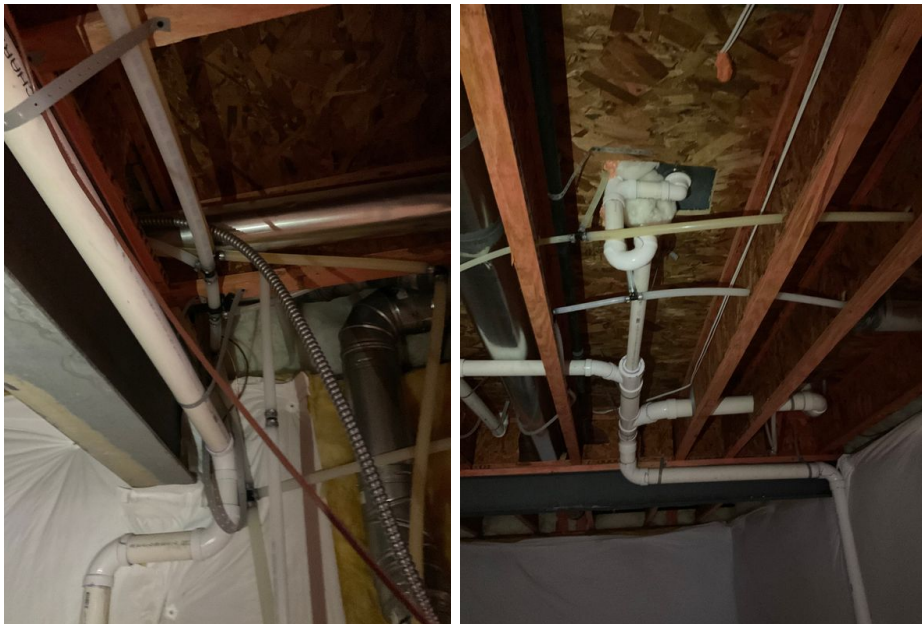
I attempted to inspect the water supply and distribution pipes (plumbing pipes). Not all of the pipes and components were accessible and observed. Inspection restriction. Ask the homeowner about water supply, problems with water supply, and water leaks in the past.

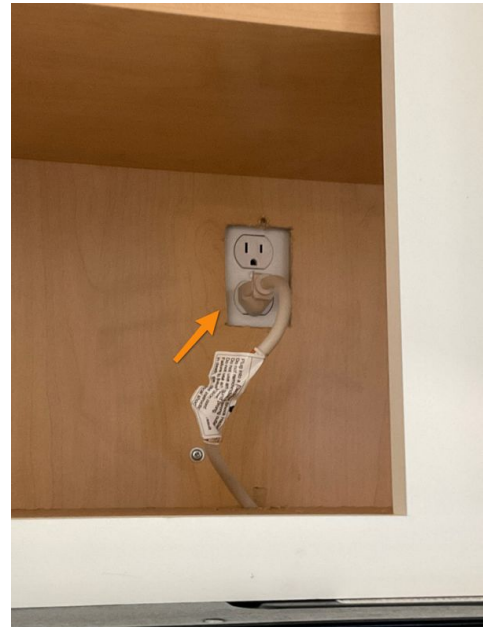
17.5.1 Built-in Microwave

PLUG FOR MICROWAVE

Major Defect

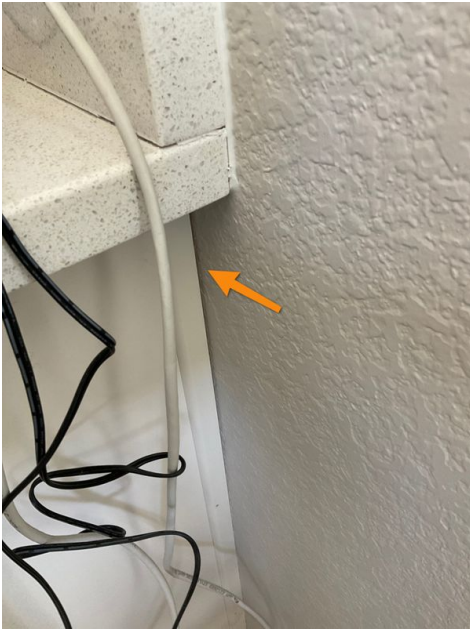
17.6.1 Countertops & Cabinets

CABINET SEPARATING FROM WALL

Major Defect

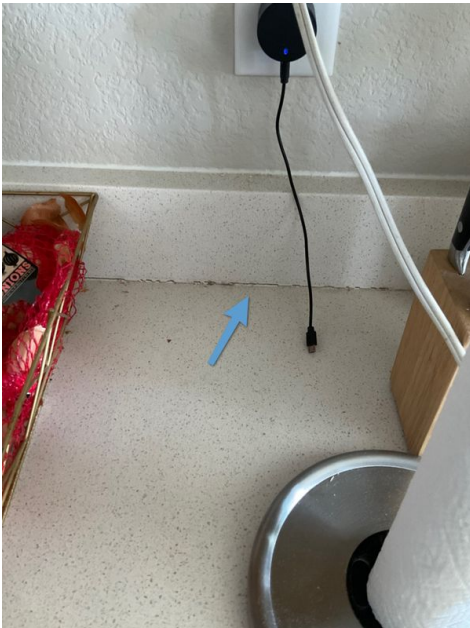
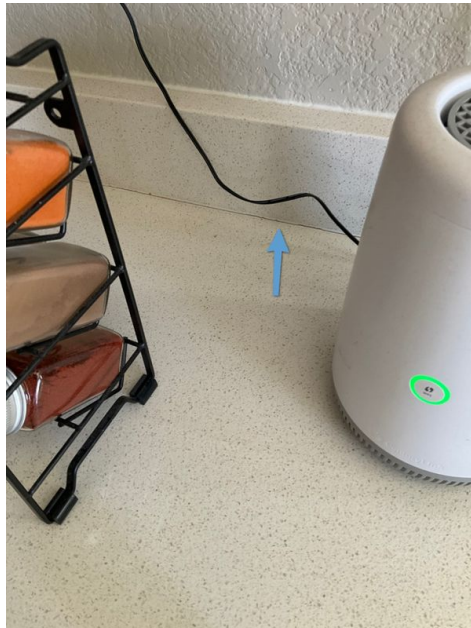
17.6.2 Countertops & Cabinets

COUNTERTOP DAMAGED

Recommendation

Contact a qualified countertop contractor.
